TECHNICAL BULLETINS - ENGLISH**LB120 CRITICAL DISC / FLYWHEEL MATCH**

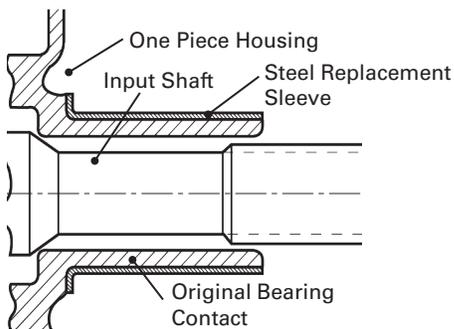
Vehicles with MTX transmissions have a one-piece aluminum housing with integral bearing retainer prone to severe wear. The wear results in binding and misalignment of the release system. Clutch sets for these applications contain a stamped steel sleeve to renew the sliding surface of the bearing retainer. The revised release bearing is designed to retain the proper bearing-to-retainer clearance when used in combination with the sleeve. This allows servicing of the one-piece housing without replacing it. Install the sleeve until the flange bottoms against the transmission housing.

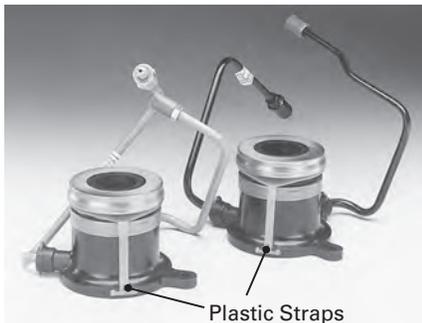
1. Do not cut the plastic straps. They are designed to hold the hydraulic piston in place during installation. They will break free the first time the clutch pedal is actuated.

2. Do not change the position of the release bearing. Moving the bearing from its position may result in damage to the seal and void the warranty.
3. Be careful not to drop the slave unit or bend the hydraulic lines. Inspect new slave cylinders for damage prior to installation. Inspect all protective

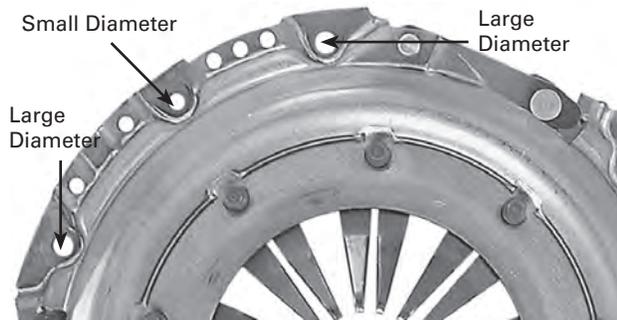
Referenced part numbers contain a diaphragm spring clutch that replaces the original coil spring clutch. The original had six bolt holes. The LuK replacement has nine holes because it is designed for use on multiple applications with different bolt patterns.

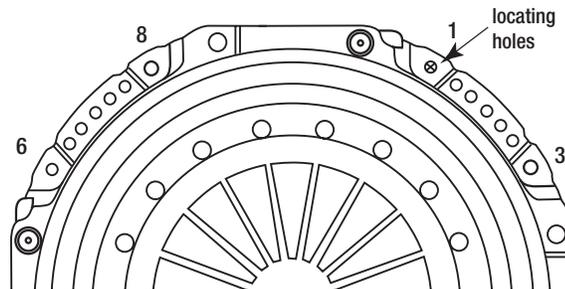
When tightening the clutch, ensure you draw the clutch down following the numbered pattern below. By starting the sequence with the two locating holes (identified by the letter "L" stamped adjacent to the bolt hole), the clutch will be centered to the flywheel bolt circle. It is important that the clutch be tightened in even increments, using only hand tools, to minimize distortion of the cover. The torque specification for the clutch mounting bolts is 15 to 20 ft-lb.

Failure to follow the recommended tightening sequence may result in clutch chatter and/or driveline vibration..

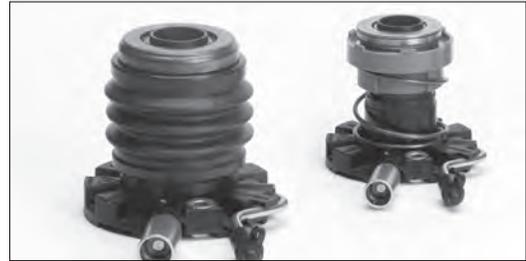
The slave cylinder you remove from the vehicle will appear similar to one of the two original-equipment designs shown below.

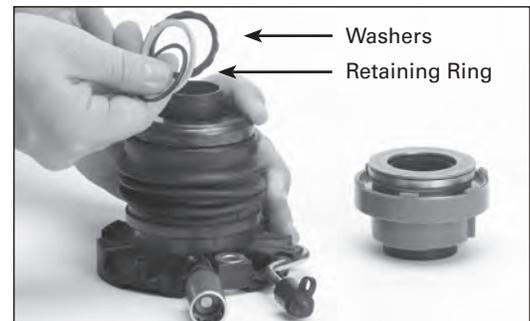
Press down on the bearing to remove the retaining ring and two washers. Discard the ring and washers.

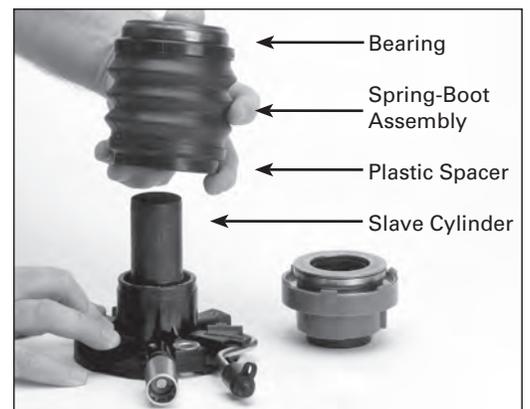
Remove the bearing, spring boot assembly and plastic spacer.

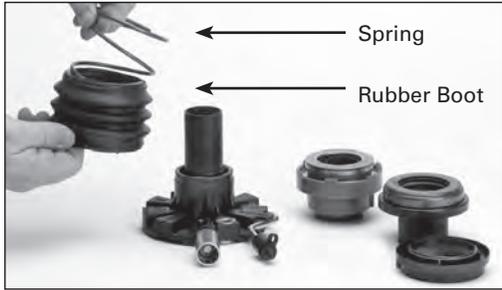
Remove the slave cylinder spring from the boot assembly, discarding the rubber boot, release bearing and plastic spacer.

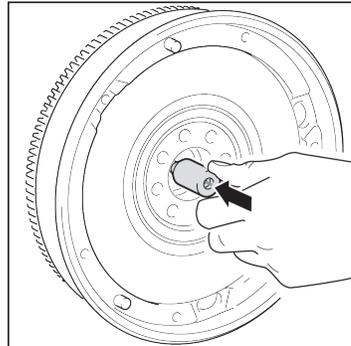
Detach the threaded bolt and insert the body of the installation tool into the flywheel pilot bearing.

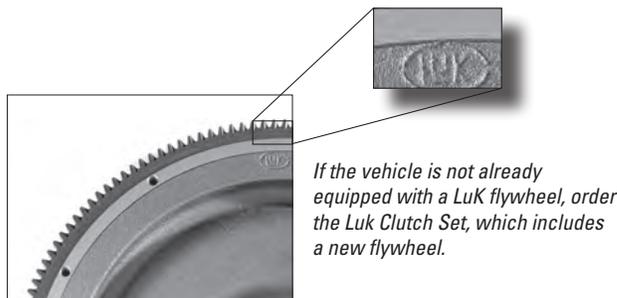
To verify the vehicle contains the correct flywheel, remove the flywheel from the vehicle and check the crankshaft side for the LuK insignia and the part number LFW140. If these are not found, order the clutch set that includes a new flywheel.

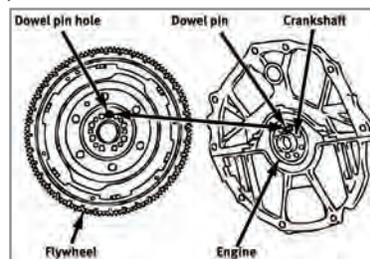
Figure 1

Then look at Figures 1-3 and find the dowel pin hole.

3. When both have been located align the two holes and torque the flywheel to the proper specifications.
4. See Figures 1-3 to aid in locating the correct dowel pin holes.
